Pearl Harbor Wetlands Inventory

Wil Chee Planning, Inc.
1018 Palm Dr.
Honolulu, Hawai'i 96814

AECOS, Inc.
45-939 Kamehameha Hwy, Suite 104
Kāne'ōhe, Hawai'i 96744-3221

November 30, 2007

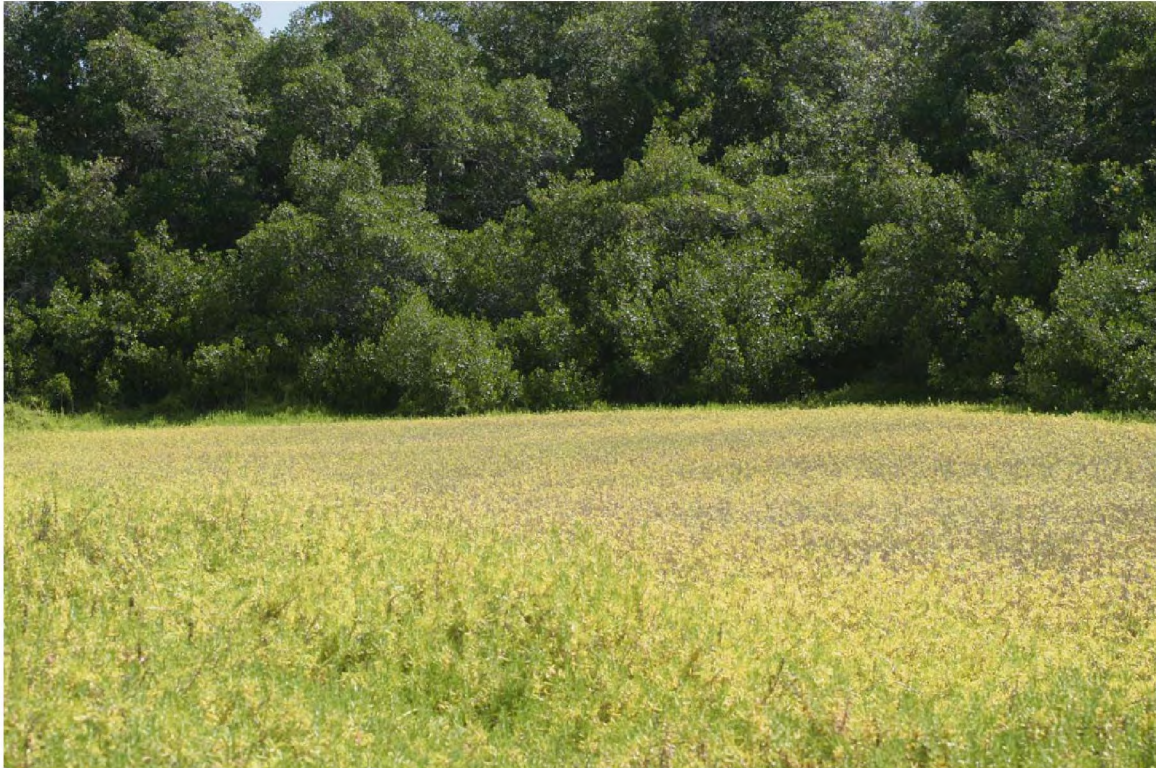
Figure 3-07. A *Batis* wetland (ID ..4070) behind dense mangal (ID ..4071) at Walker Bay.

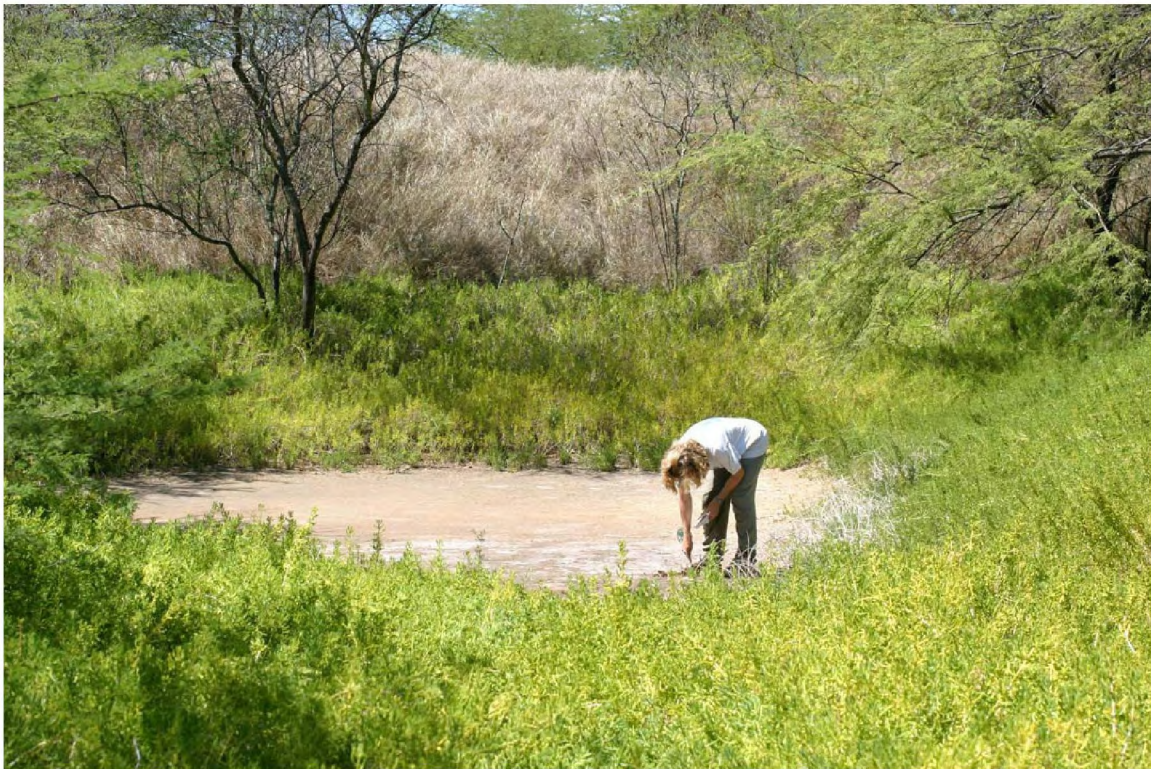
Figure 3-08. A playa feature inland of Walker Bay. Note that *Batis* grows away from the central depression, which is bare of vegetation (and salt encrusted) indicating this is an ephemeral, saline wetland. Also, note the steep basin wall covered in dry grasses.

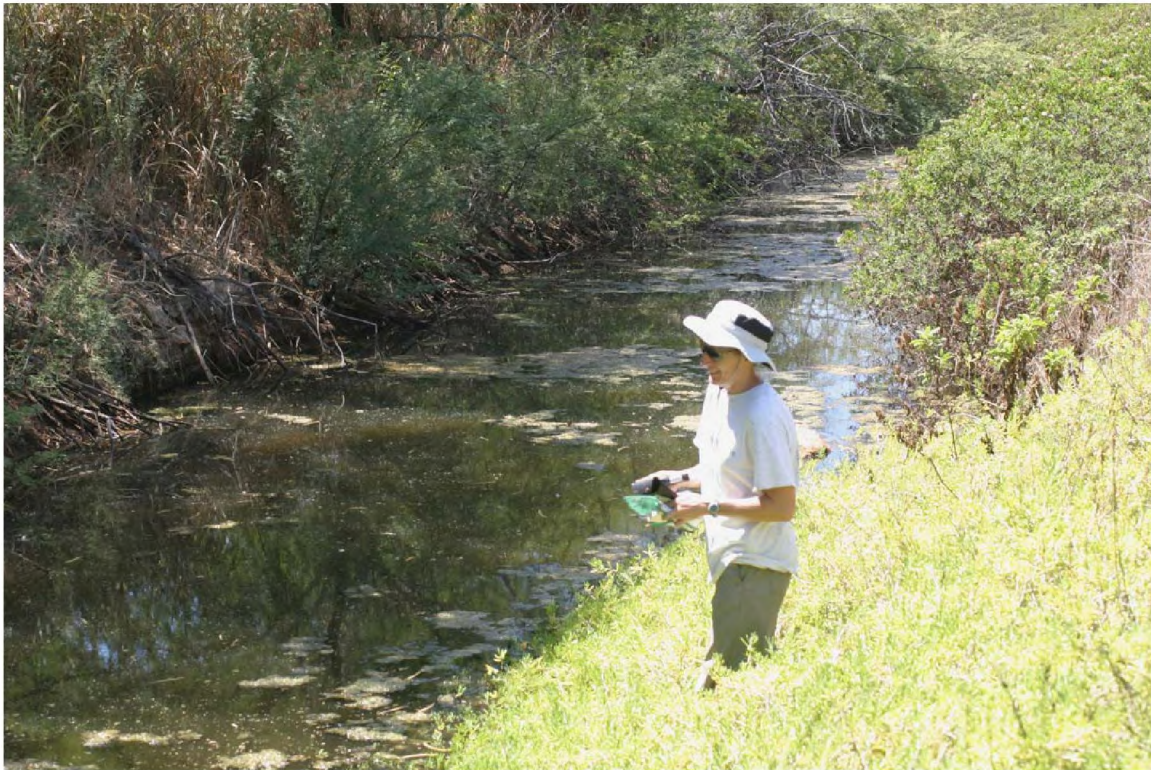
Figure 3-09. Drainage ditch inland of the south shore of Walker Bay.

South of Walker Bay, the Peninsula narrows to Waipi'o Point at the southern tip. Some of this area was leased for farming in the past, and drainage ditches are present, some near the shore supporting “wetland” vegetation such as *Batis* and *Pluchea* (Fig. 3-09). A few scattered wetlands appear on the NWI maps

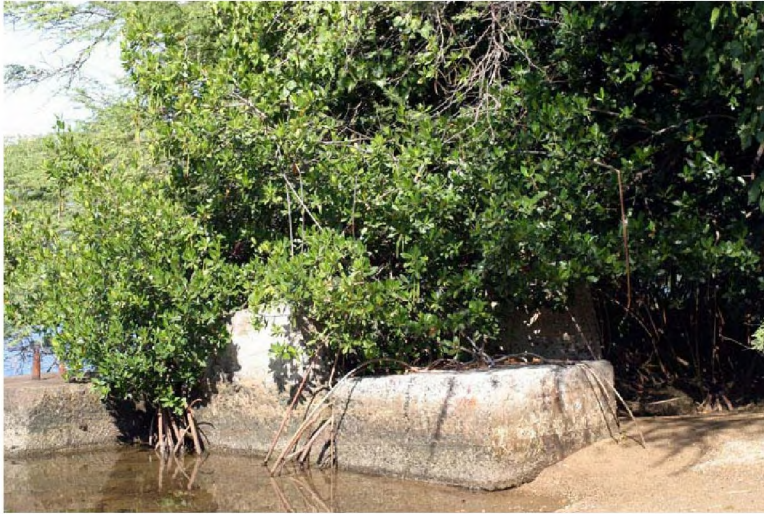
SP3-01 (left): Red mangrove growing on a concrete block and adjacent rocky cliff, a situation that fails to fit into a wetland definition.

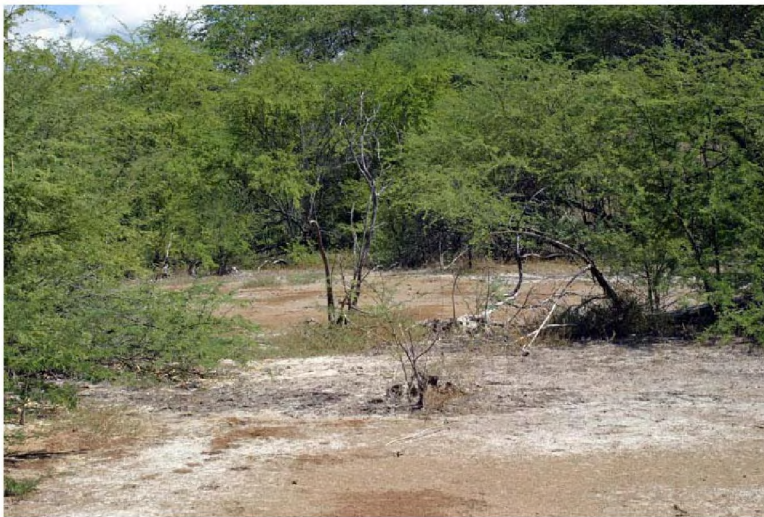
SP3-02 (left): Another one of the playa-like depressions near Walker Bay (see Fig. 3-08). Here the only vegetation is *kiaue*. Note salt-encrusted soil, the only plausible explanation for which in the closed depression is evaporation of saline groundwater.

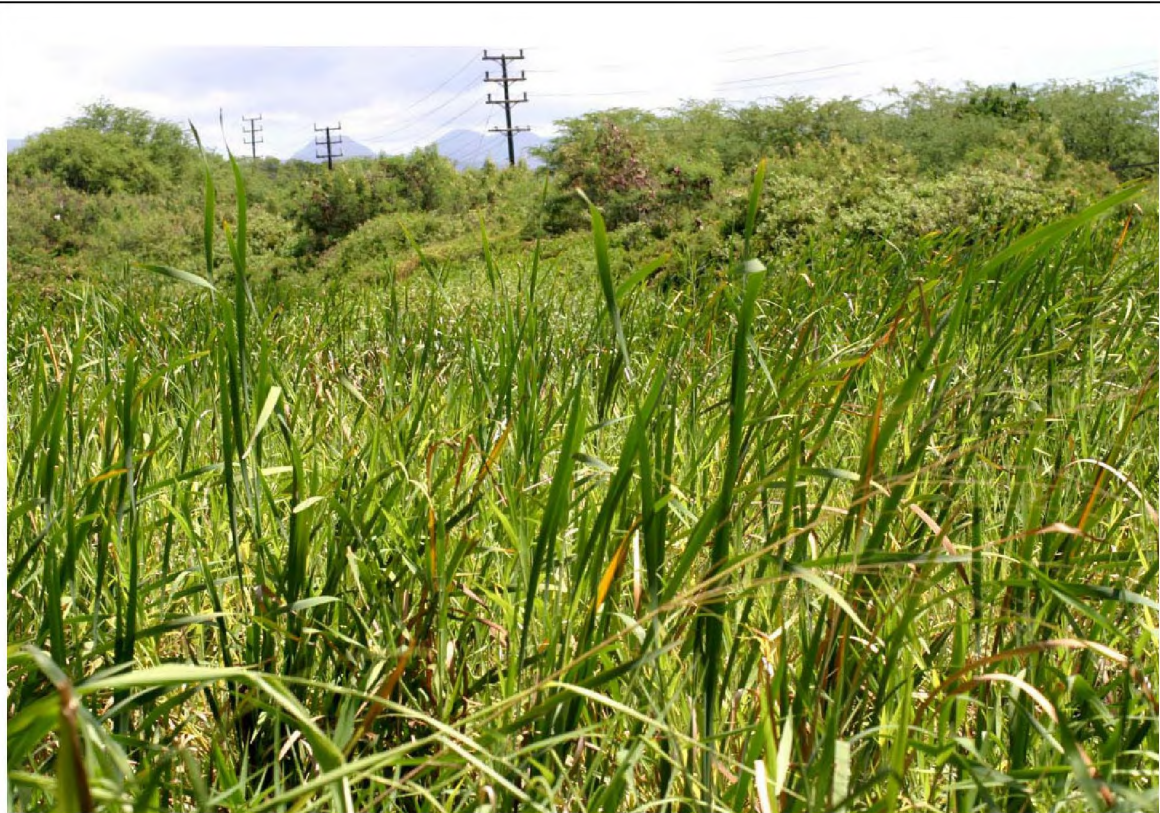
Figure 4-02. Kolea Cove wetland as it appeared in September 2006 looking into the wetland from the northwest corner. Poles and trees in background are along the bike trail.

Although this wetland is still present, access to view the wetland has become difficult by the fact that dense vegetation now obscures the fence, wetland margin, and most or all of the open water of the feature. The wetland is overgrown with California grass (*Urochloa mutica*) and cattail (*Typha latifolia*; Fig. 4-02). This feature is not indicated on the NWI maps (USFWS, 2007).

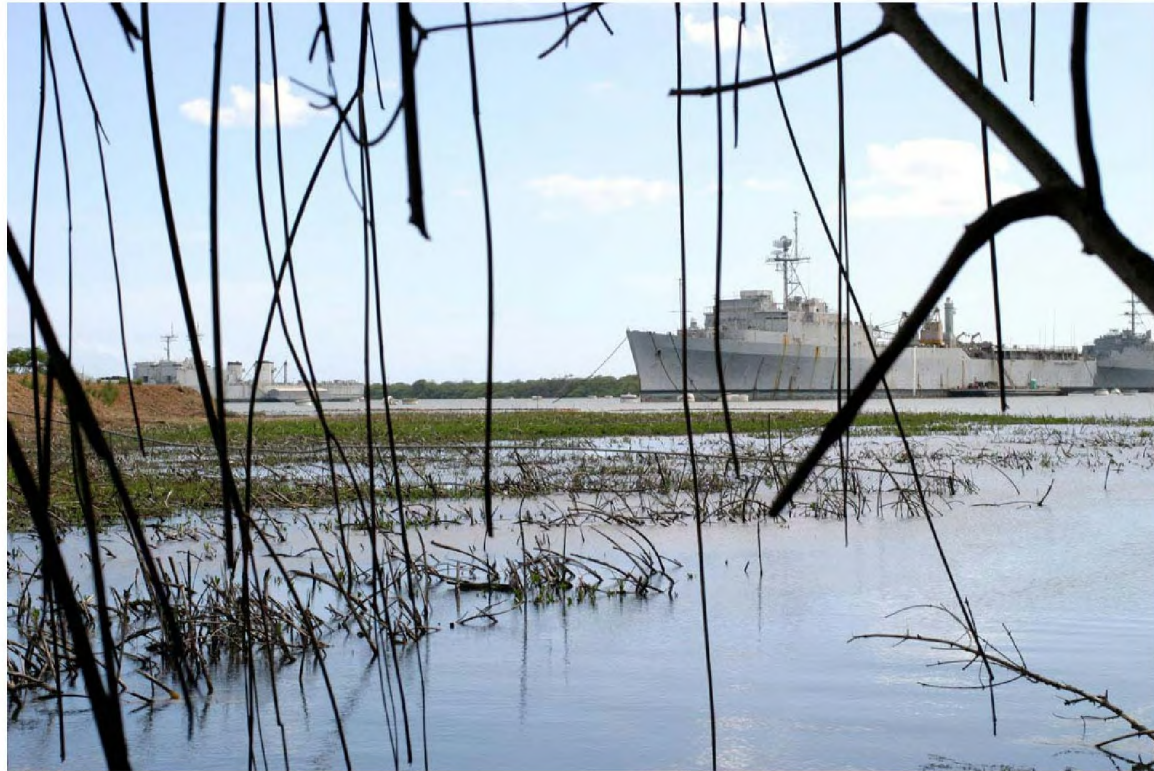
Figure 4-03. Mangal [ID ..6079] denuded of mangrove trees fronting the Waiawa Unit, PHNWR (to left out of frame). Mangroves from which this photo was taken in September 2006 were later also removed.

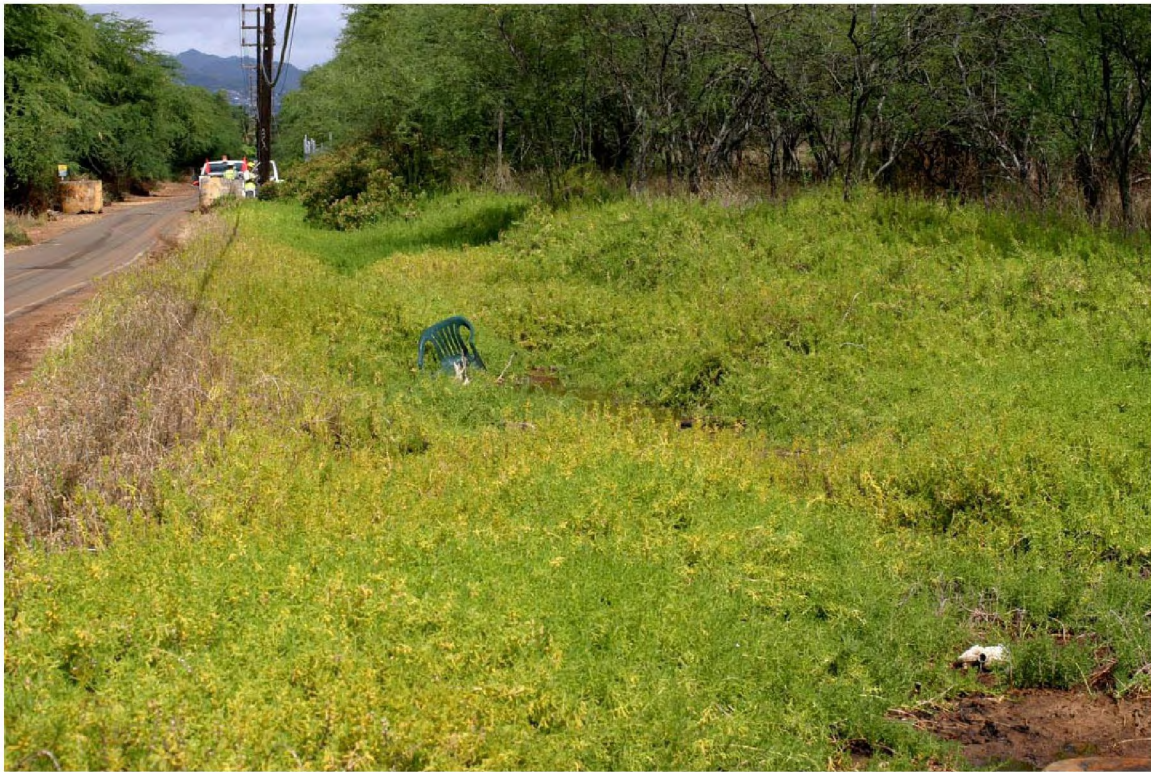
Figure 4-04. A small pickleweed wetland in the drainage ditch on the south side of the bikeway.

Some water from the springs in this area floods westward beside the bike trail, creating small wetlands just off the trail and feeding man-made ponds in the area. On the south side of the trail, however, a shallow drainage ditch (ID ..6121) is covered in pickleweed (*Batis maritima*; Fig. 4-04), suggesting an infrequent but significant tidal connection, and disconnection from the abundant freshwater present elsewhere just north of the bike trail.

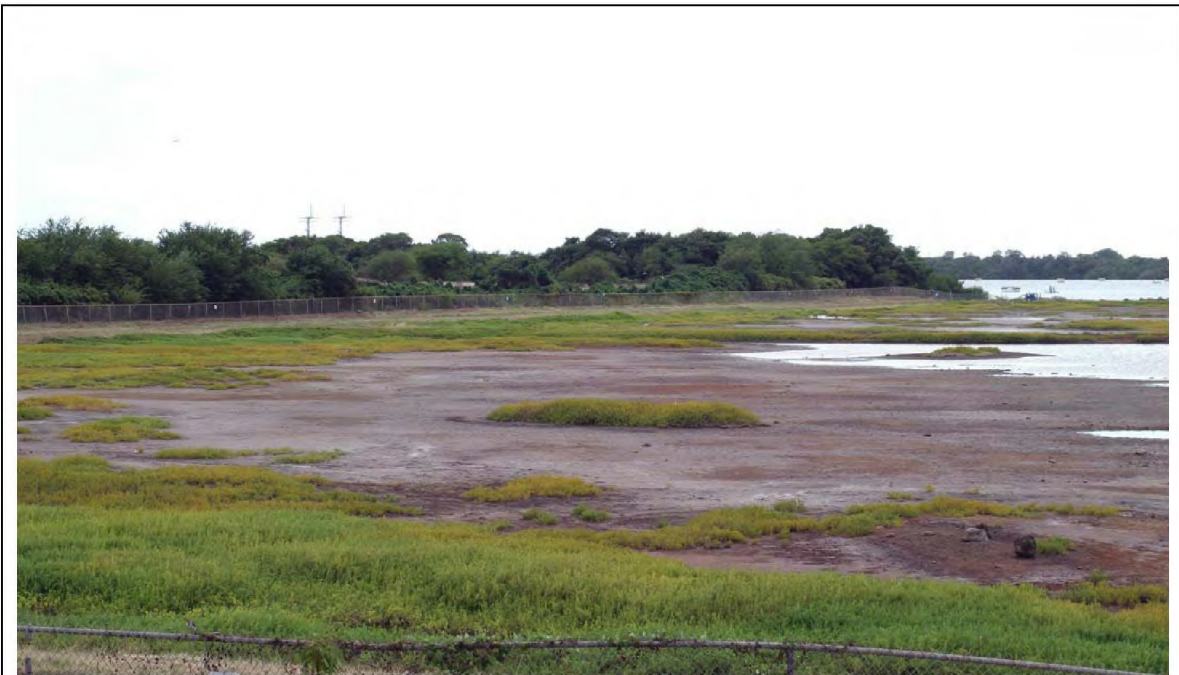
Figure 4-05. Northernmost (ID ..6080) of the two ponds at the Waiawa Unit of the PHNWR, looking southwest. The dominant vegetation is pickleweed.

The Waiawa Unit of the Pearl Harbor National Wildlife Refuge (PHNWR) is a 25-acre (10-ha) site on U.S. Navy land with two ponds (Fig. 4-05) supplied with fresh to slightly brackish water pumped from the nearby outlet of the Waiawa Springs complex (USFWS, 2006). As at the Honouliuli Unit of PHNWR (see Chapter 1), the site consists of two diked ponds (IDs ..6080 and ..6081). These drain via a short outlet located along the Middle Loch shore.

Each pond is classified differently in the NWI (USFWS, 2007). The northern pond (ID..6080) is an open central pond, E1UBL (estuarine unconsolidated bottom subtidal) with margins E2EM1N: (estuarine persistent emergent herbaceous vegetation regularly flooded wetland). As pointed out elsewhere (see Introduction, p. 21), the correct code is E2SS3P. The southern pond (ID ..6081) is presently coded E1ABL (estuarine subtidal aquatic bed; i.e., submerged aquatic plants). Since both ponds are excavated features, in general similar to the ponds at the Honouliuli Unit (see page 46), the codings should be similar but are not.

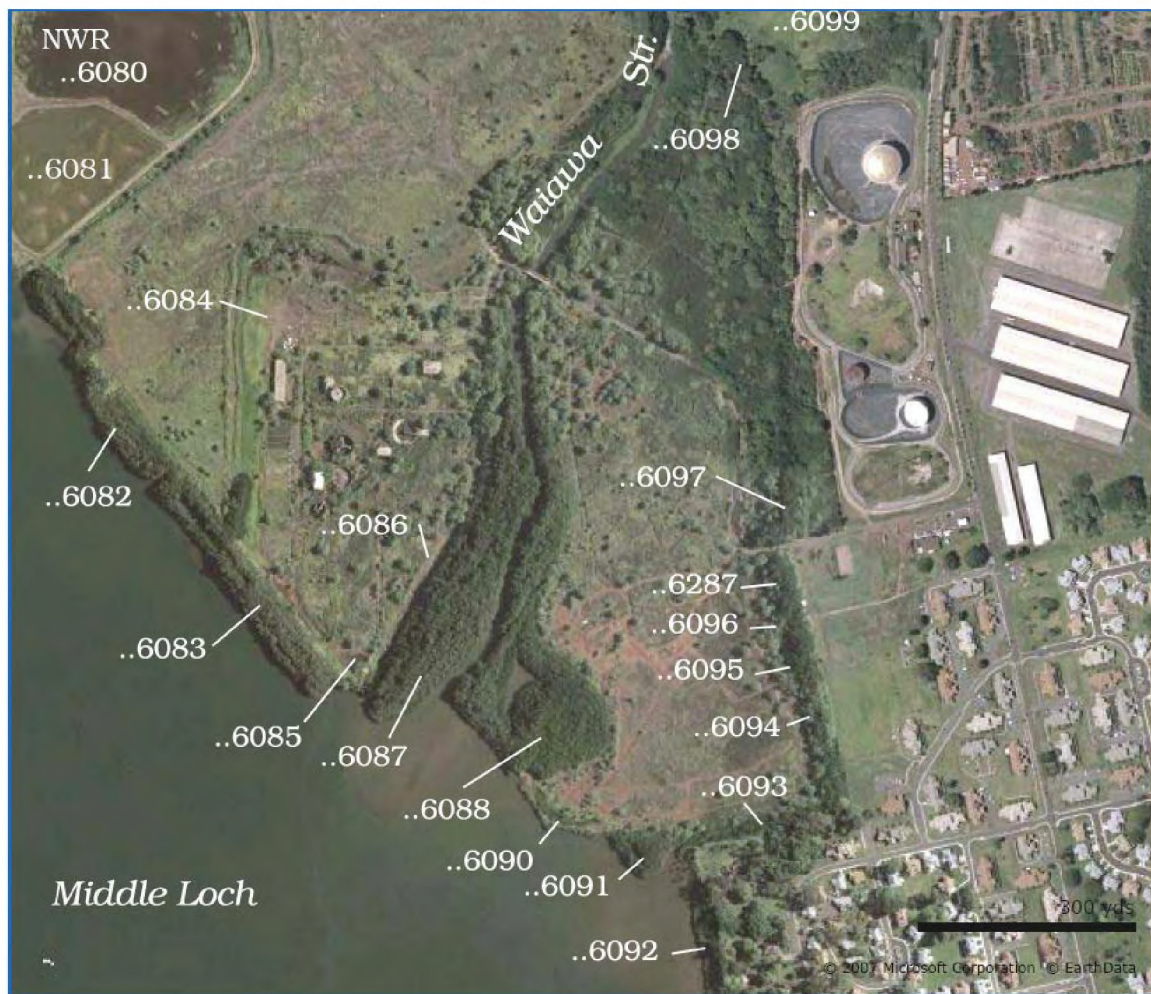
Figure 4-06. Satellite image of the lower end of Waiawa Stream and the abandoned WWTP to the west on the western side of the Pearl City Peninsula.

Waiawa Stream drains the west side of Pearl City, forming a double horseshoe bend as it flows out onto the coastal plain directly north of the center of the Pearl City Peninsula (Fig. 4-06). The stream continues to meander down the peninsula before flowing into Middle Loch nearly half way down the west side. The upper half of the peninsula is a floodplain that once supported extensive rice culture (PHRI, 1993). The mouth of the stream is a mangrove forest or mangal, and indicated on NWI maps as E2FO3N: estuarine, intertidal, regularly flooded, broad-leaved evergreen forest (USFWS, 2007) and shown extending upstream nearly to the point where Waipuna Avenue crosses the stream.

North-South Drainage Ditch ~ The southern wetland area described above (ID ..6098) drains out through a ditch directed nearly due south (ID ..6093 to ..6097 and ..6287; Fig. 4-06) along the west boundary of the former Navy tank farm. This ditch eventually turns westward behind naval housing units on Ashley Avenue. The numerical subdivisions of this wetland feature by ACOE (1999) represent segments between now abandoned concrete road bridges. The wetland is one continuous feature marked by a monotypic stand of red mangrove. A bridge crosses this ditch at Waipuna Ave., providing road access to the now abandoned C&C WWTP. Below the Waipuna Avenue bridge, standing water is evident all along the ditch, but mangroves form a closed canopy forest over the water. At one point the ditch wetland expands, forming a small

Former Pearl City WWTP Site ~ A former C&C waste water treatment plant (WWTP), now abandoned, is located west of the mangal along lower Waiawa Stream and is surrounded by wetlands (see Fig. 4-06). The WWTP was built on fill land that is at a generally lower elevation than surrounding parcels, which are also fill. The site is thus separated from the surrounding land by various berms or dikes, including on the east, a dike that contains flood waters of Waiawa Stream. To the south and east are narrow wetlands (..6085 and ..6086) separate from both shoreline and stream mangals (that is, IDs ..6083 and ..6087).

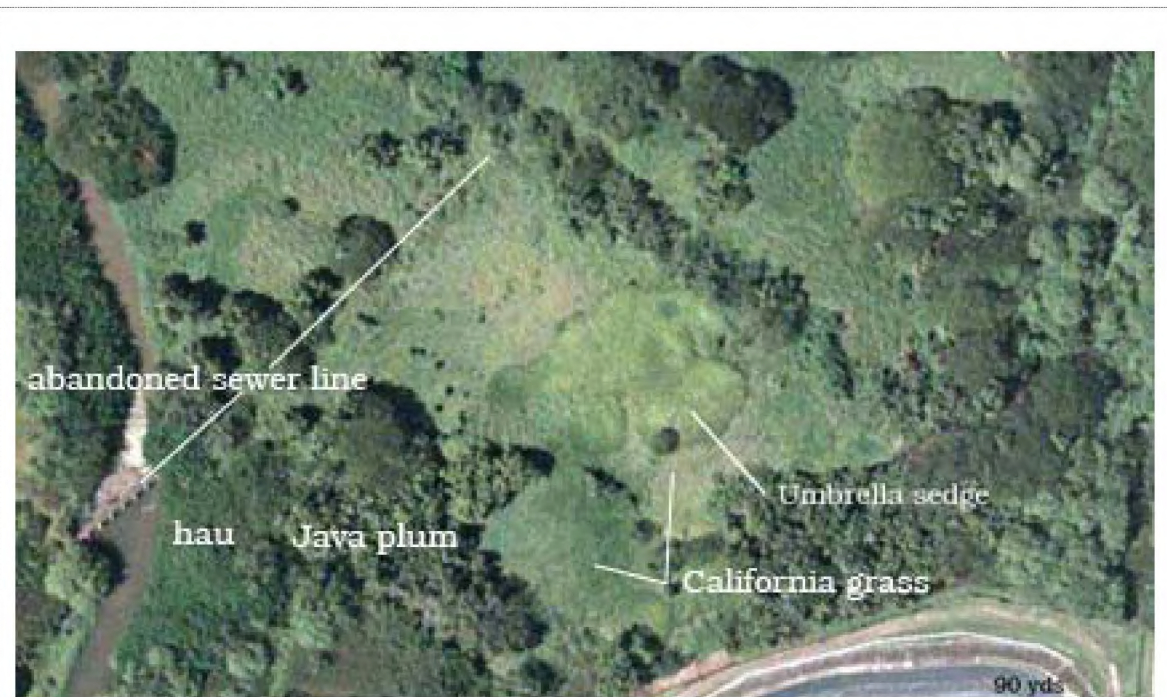
Figure 4-07. Waiawa wetlands seen in a satellite image (Microsoft, 2007). The dense, monotypic growth of umbrella sedge is readily apparent, distinct from the surrounding California grass.

We were only able to access some parts of the wetlands in this area due to the density of the surrounding vegetation of mostly elephant grass (*Paspalum purpureum*). The ACOE (1999, p. 34) noted, for the westernmost wetland [ID ..6101] that “[e]lephant grass is encroaching into the area and is decreasing the jurisdictional area.” We could not confirm that this wetland still exists. On the other hand, ID ..6098 is mostly a forest of Java plum (*Syzygium cumini*) and not a wetland, although towards the outlet feeding to a north-south drainage ditch (see below), *hau* (*Hibiscus tiliaceus*) and some mangrove (*Rhizophora mangle*) comprise a small swamp. The central area of the marsh remains dominated by umbrella sedge and California grass as described by ACOE (1999; see Fig. 4-07).

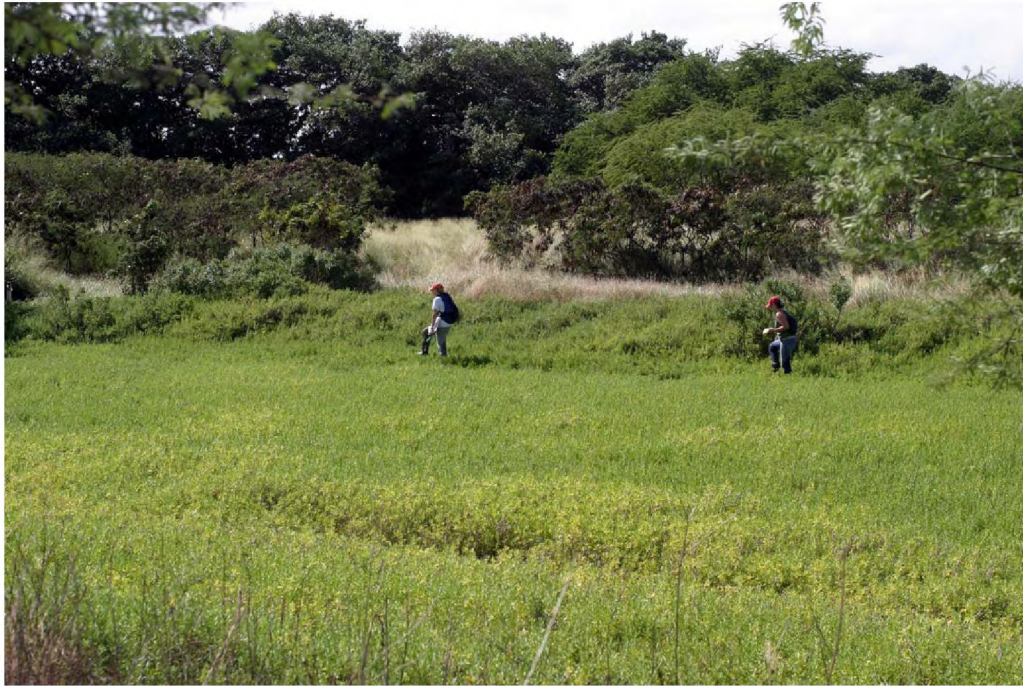
Figure 4-08. Pickleweed wetland on the west side of the old Pearl City WWTP. Biologists shown walking the wetland boundary with a GPS unit. Note that pickleweed grows up the bank, well beyond the wetland border.

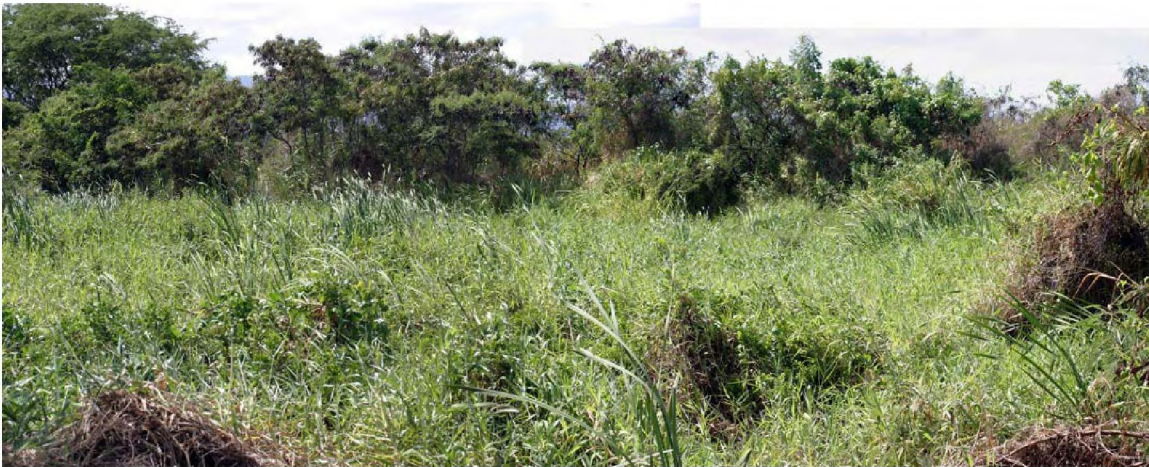
SP4-01 (above): One of the small pond wetlands (ID ..6124) fed by spring water in the Waiawa area showing how vegetation such as cattail and California grass can completely overgrow a freshwater wetland.

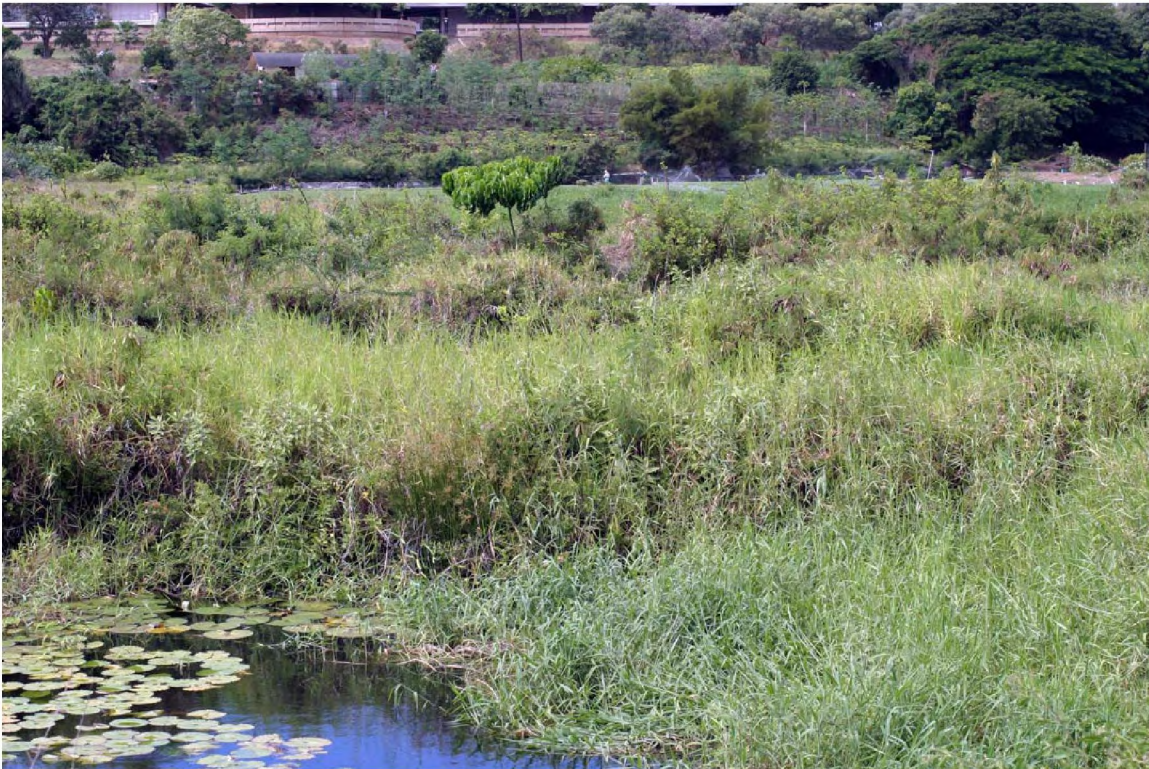
SP4-02 (above): Another pond (ID ..6120) in the same area as photo above. Because of a deeper basin and perhaps more recent use, the open water is not yet obliterated by California grass (growing out onto water surface from right).

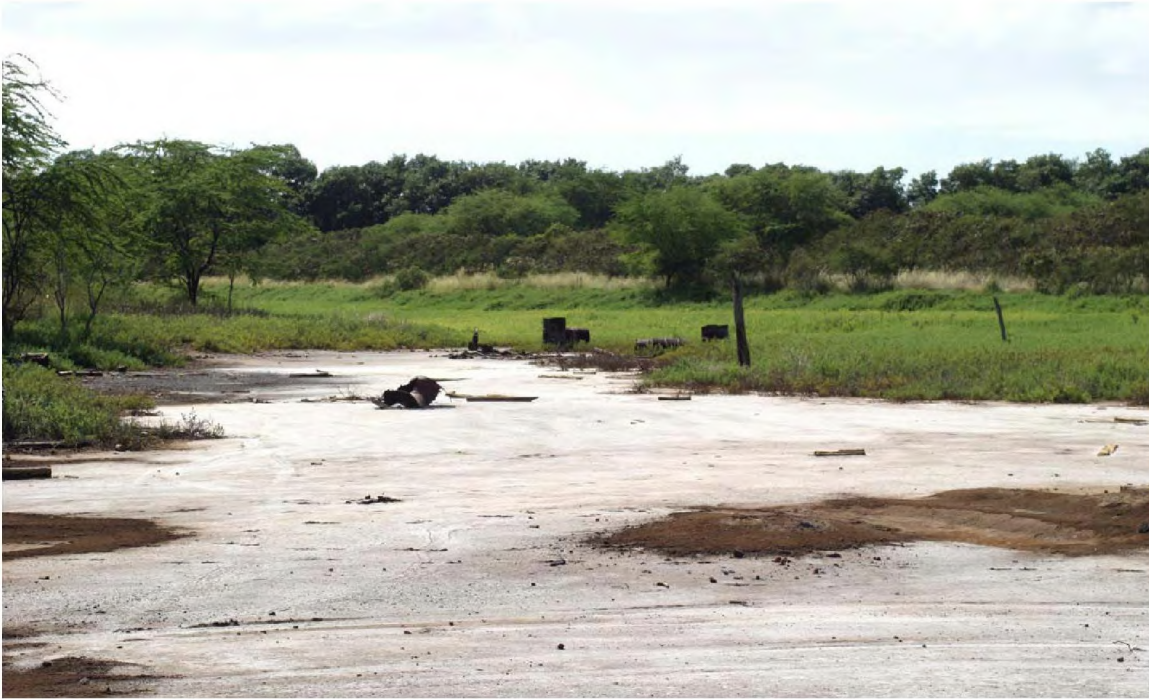
SP4-03 (above): Salt encrusted soil at north end of the playa (ID ..6084) at the abandoned Pearl City WWTP.

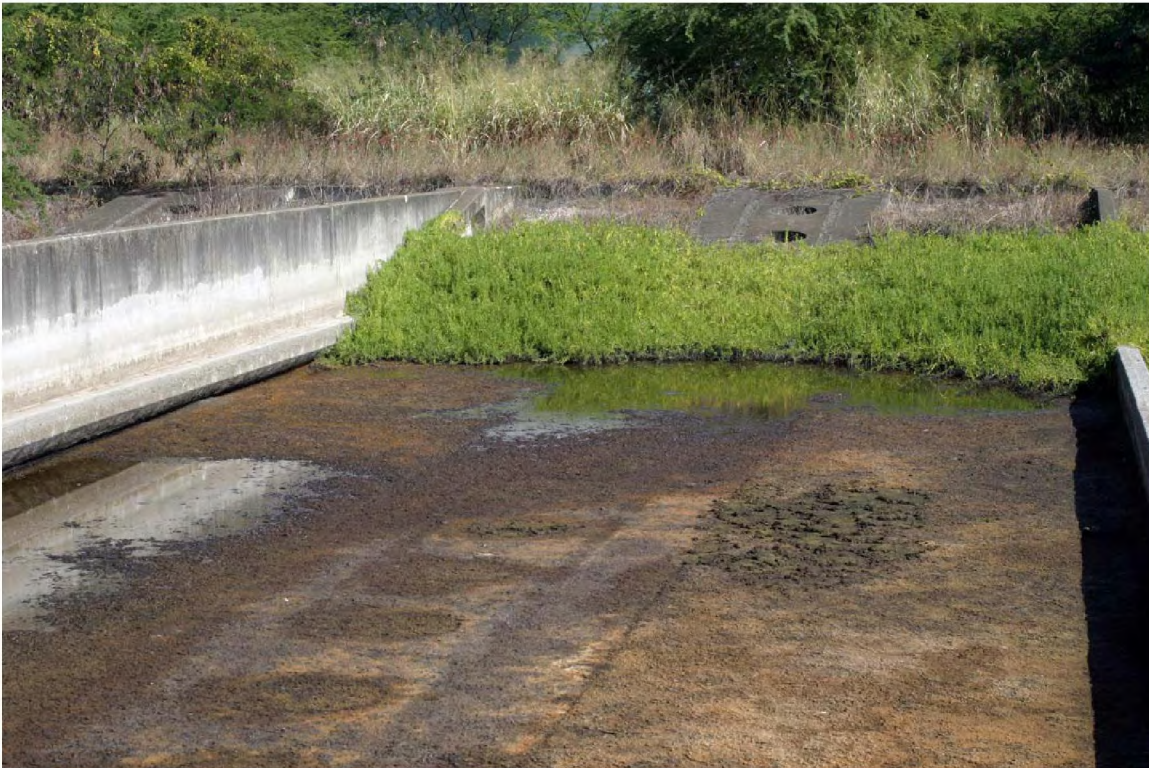
SP4-04 (above): The abandoned sludge drying pits at the Pearl City WWTP are large concrete depressions that collect rainwater, support wetland plants (*Batis maritima*), and are visited by foraging Hawaiian stilt.

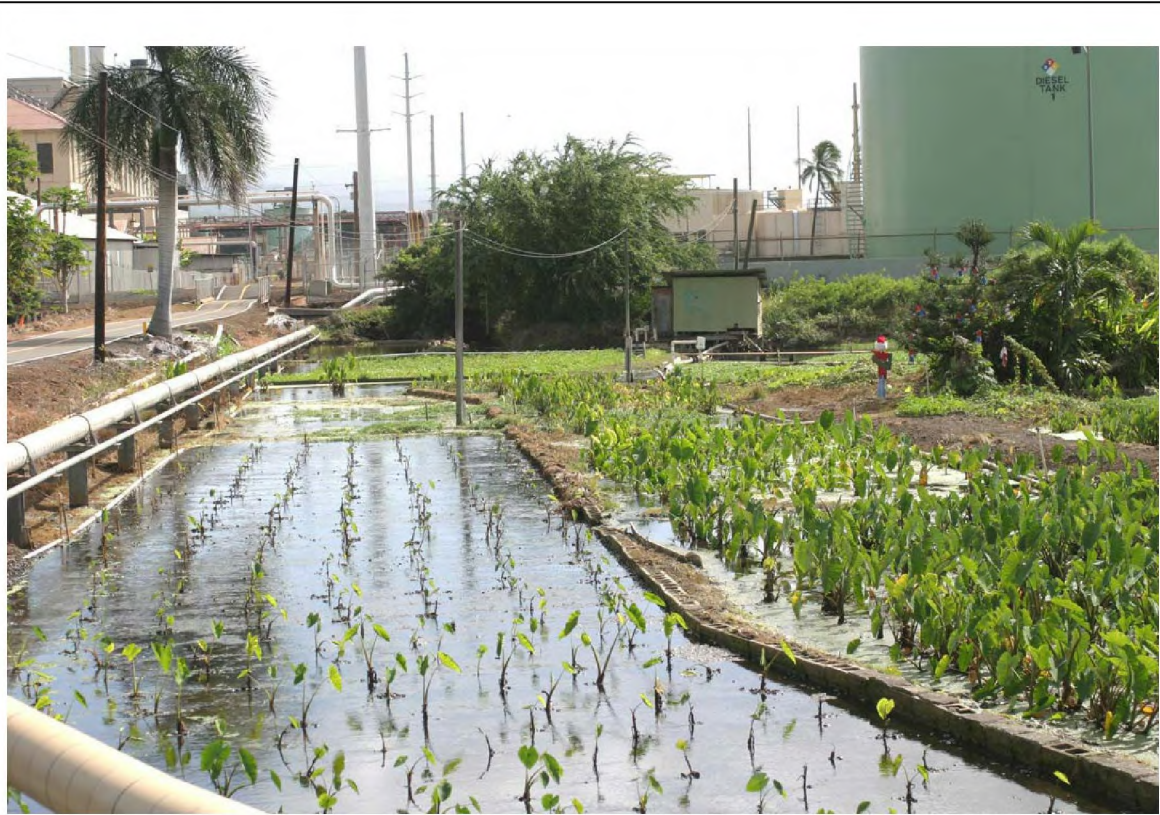
Figure 5-03. Taro, ung choi, and watercress pondfields or *lo'i* (ID .. 7259 and ..7260 in foreground) utilizing spring water flowing towards East Loch on the west side of the HECO Waiau Generating Station (background).

The public bike path can be seen on the left.

Wetlands west of the HECO Generating Station end in the *mauka* direction more or less abruptly at the H-1 viaduct. Although the Interstate is supported on piles high above the ground in this section, any wetland features that were present within the r-o-w of the freeway were apparently filled in. The swath cut by the freeway through former wetlands here is evident in Fig. 5-02. Waimano Drainage Channel crosses under the viaduct in an open culvert, and a pipe culvert to the east drains a wetland (ID ..6255) on the north side of the freeway. This particular wetland was surveyed by Guinther (2003) and found to be fed by several springs. The wetland status of the westernmost portion is not firmly established (due to the nature of the soil), but the area was an abandoned pond field overgrown with dayflower (*Commelina diffusa*) and fed by a capped and valved freshwater spring located close to the man-made channel of Waimano Drainage Channel. The springs in this area feed pondfields (Fig. 5-03; also SP5-02) along the bike path west of the HECO Generating Station (ID ..7257 through ..7267).

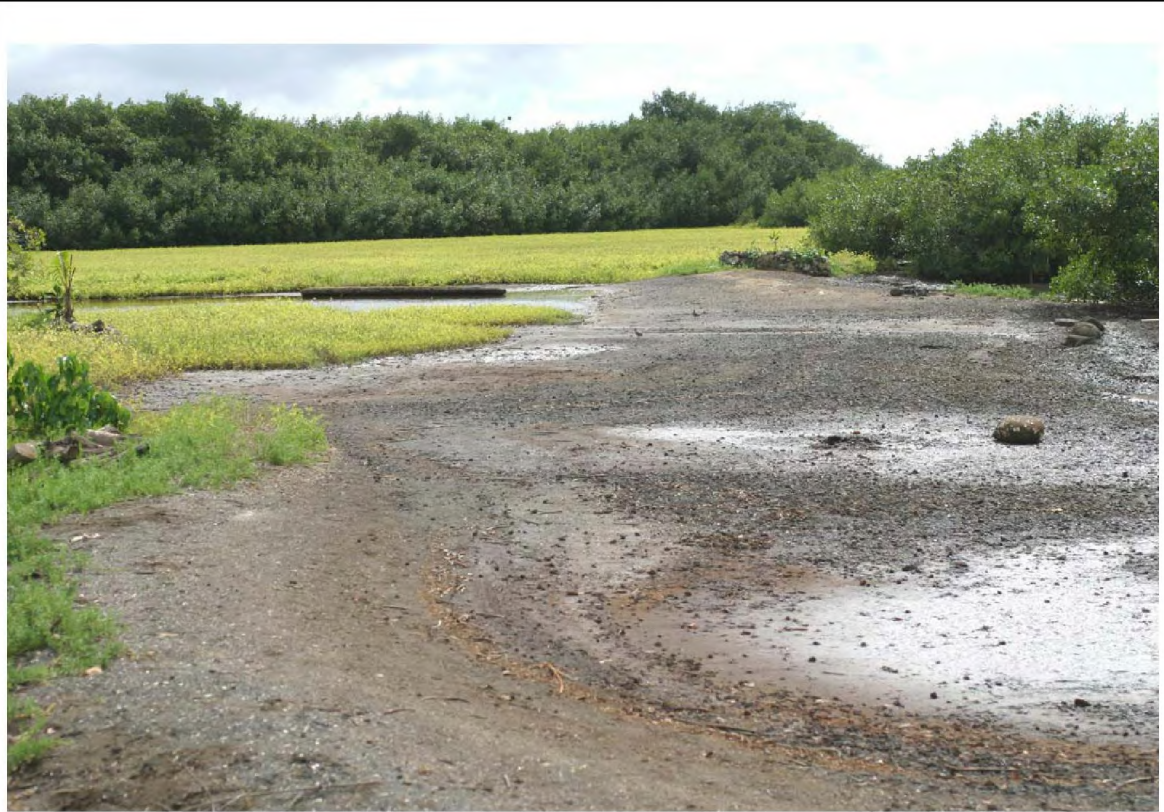
Fig. 5-04. Wetland (ID ..7140) at Neal S. Blaisdell Park in Pearl City. The estuary of Waimalu Stream lies beyond the mangal (ID ..7145) in the back; East Loch is beyond mangal (ID ..7142) on right.

The west side of the delta of Waimalu Stream is a wetland (Fig. 5-04; ID ..7140) covered by a monotypic stand of pickleweed, with the large stand of mangrove on Wamalu estuary (ID ..7145; east side) and along much of the harbor side (ID ..7142 to ..7144). The inland boundary of this wetland is defined by the bike trail as it passes through Neal S. Blaisdell Park in Pearl City.

This area (especially the adjacent mangal) is utilized by homeless persons that have set up camps in and adjacent to the Park. In the wetland, rock-walled planters have been constructed to grow ornamental and food plants. Two such planters are visible in Fig. 5-04: one on the far left with a small palm tree, and one on the right close to the mangroves, where ti plants and squash or cucumber plants are being tended (see also photo SP5-04).

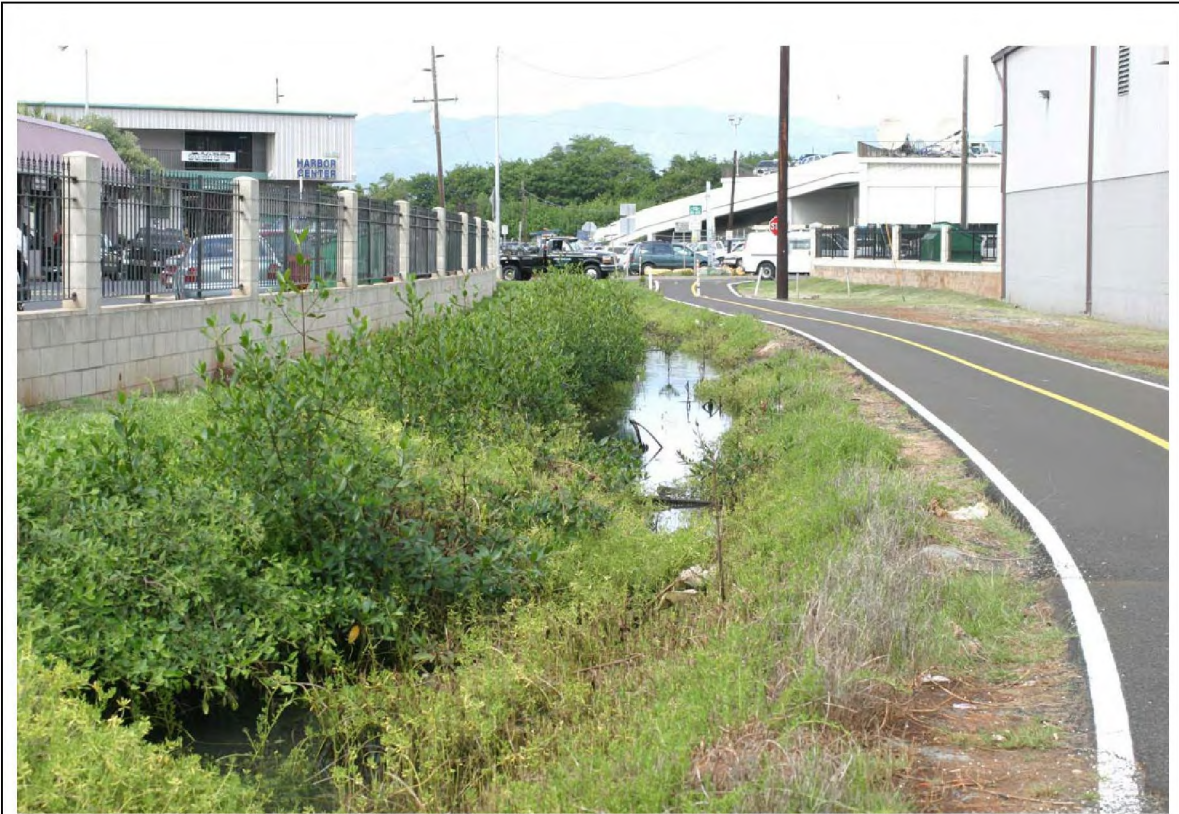
East Loch some 220 ft (70 m) east of Waimalu Stream mouth. A portion of this drainage system includes open ditches on either side of Hekaha Street along the south side of the bike path. These ditches are apparently tidal, and support small wetlands (ID ..7152), dominated in one case by seashore paspalum (*Paspalum virginicum*) with a sparse growth of pickleweed, and pickleweed, mangrove, and Indian fleabane in the other case (Fig. 5-05).

Figure 5-05. Drainage ditch along bike path adjacent to Harbor Center (left) in Pearl City (Hekaha St. at stop sign).

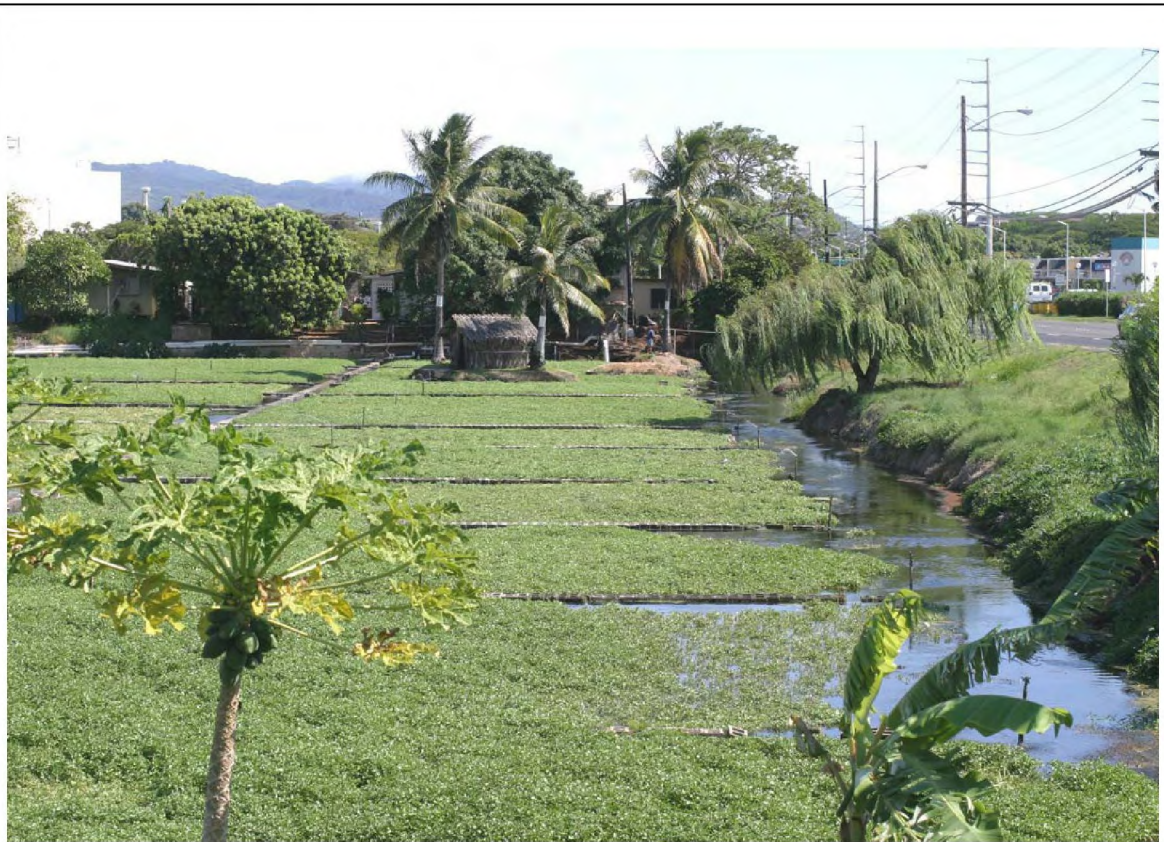
Figure 5-06. Sumida Farm: watercress farming in pond fields. Only the downstream or *makai* end of an extensive growing area is shown here.

Kalauao Spring and Sumida Farm ~ Kalauao Spring is one of the many large springs that issue from the bedrock inland of the shore of East Loch. In this case, the spring issues forth *mauka* of Kamehameha Highway (State Rte. 99) in a low area surrounded by the Pearl Ridge Shopping Center and the water is utilized to support extensive wetland watercress farming at Sumida Farms

(Fig. 5-06, above). In 1964, the maximum width of the spring area was 244 m (800 ft), extending to the south side of Kamehameha Highway (Visser and Mink, 1964).

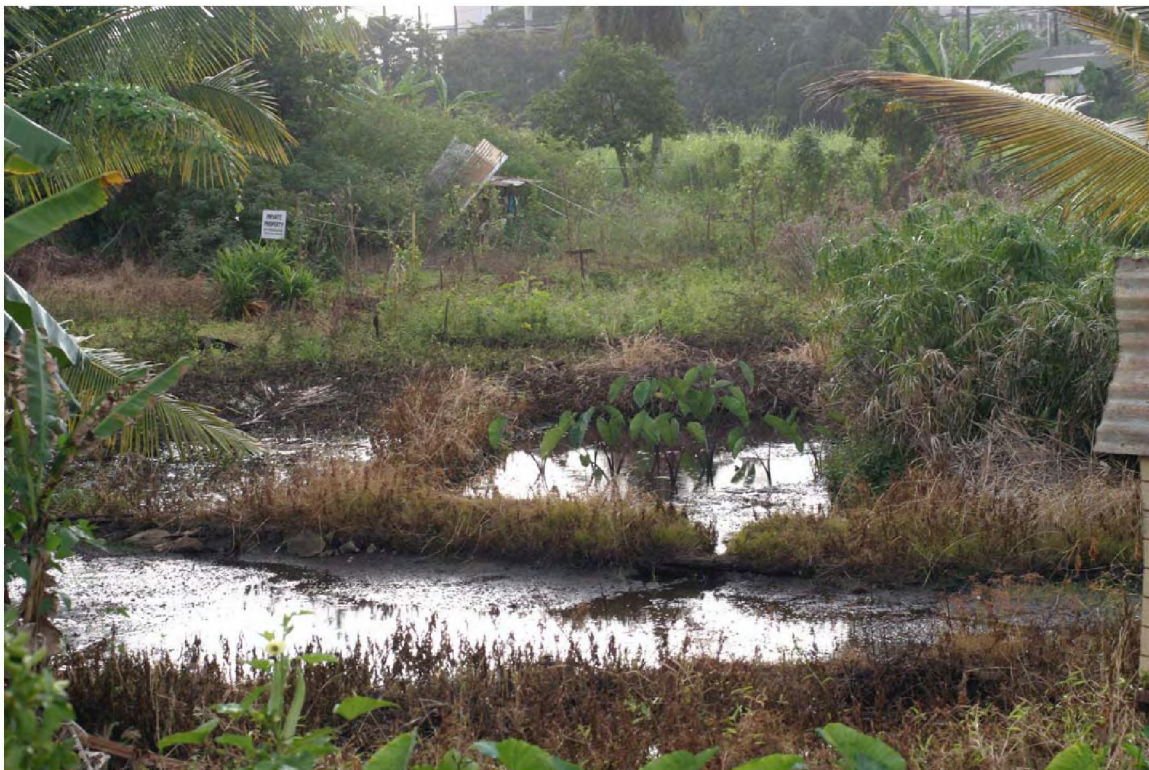
Waiau Spring arises some 1300 ft (410 m) inland of the shore and its perennial discharge, Waiau Stream, flows through small watercress (*Nasturtium microphyllum*) and taro plots and then a pond and wetland (ID ..7128) before entering a concrete culvert under Kamehameha Highway (State Rte. 99) and then a narrow channel on the east side of HECO's Waiau Power Station. This remnant wetland (see photo SP5-01) can be observed from the Zippy's parking lot off Kamehameha Highway or from an access road at the intersection of Kuleana Road and Kuleana Place. A concrete culvert curves around the east side of the wetland and directs drainage from the H-1 Interstate/Moanalua Road interchange past Zippy's to a culvert under Kamehameha Highway. The wetland appears to be mostly overgrown with California grass, water hyacinth, and umbrella sedge, with small pond field areas of ung choi and taro. Open water (primarily at the south end) supports the tape grass (*Vallisneria*), a submerged aquatic plant, which we observed being harvested.

SP5-01 (above): The small wetland (ID ..7128) fed by Waiau Spring is adjacent to Zippy's on Kamehameha Highway and supports local wetland gardening.

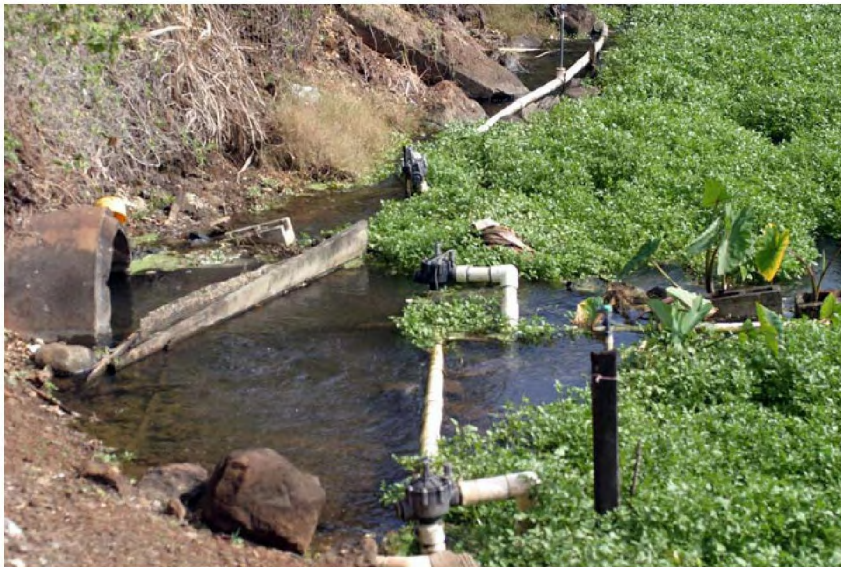
SP5-02 (left): Outlet of the pipe that carries water from springs located north of the H-1 freeway to pondfields (ID ..7266) directly west of HECO Waiau Power Station. Watercress and taro shown.

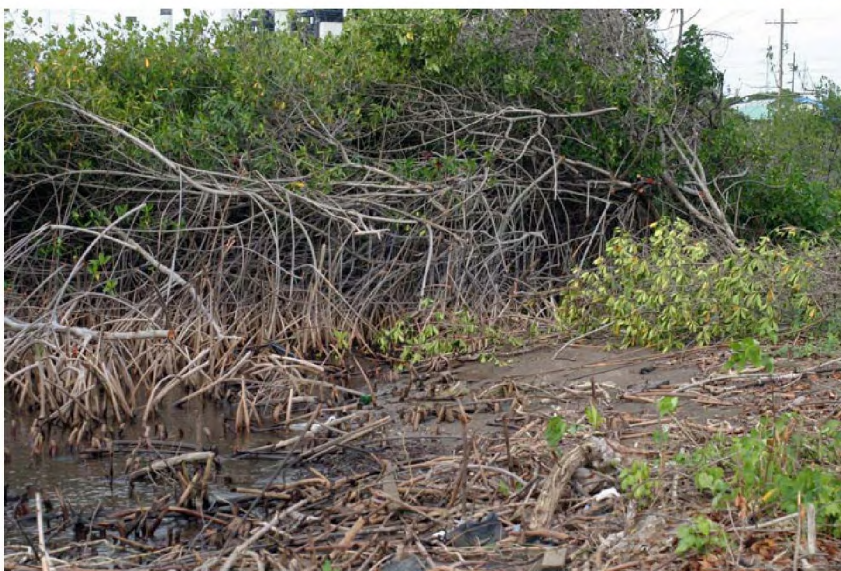
SP5-03 (left): Mangrove removal in progress along the shoreline west of Blaisdell Park.

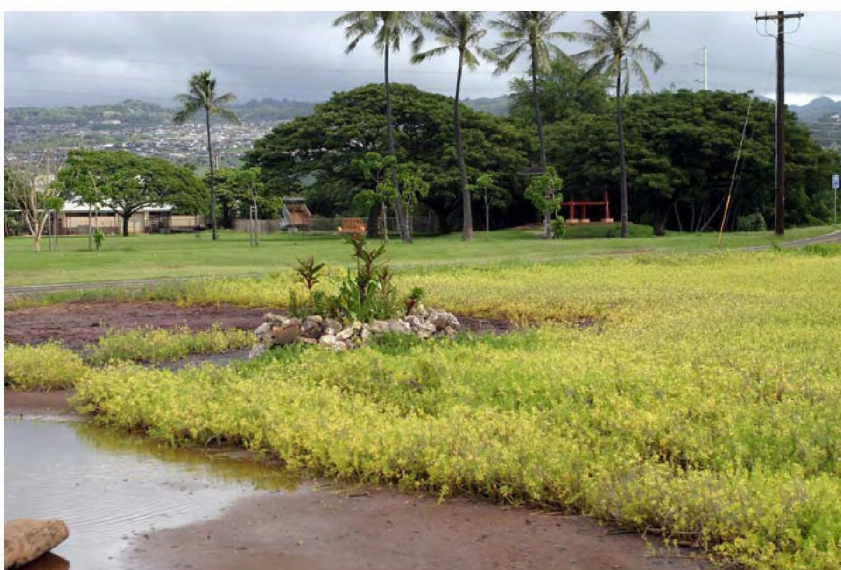
SP5-04 (left): View from the shoreline into wetland at Blaisdell Park (ID ..7140) showing “garden” constructed of boulders in order to raise soil above the tidal influence.
